The deterioration of Apuan white marble in contemporary architectural context

Research aim:

This paper reports the results obtained from the analyses carried out on marble slabs used as floor, cladding and sloping roof of the Oslo Opera House in order to understand the causes of the intense yellow discoloration and to investigate their state of conservation aiming to define new guidelines for the maintenance of the building.

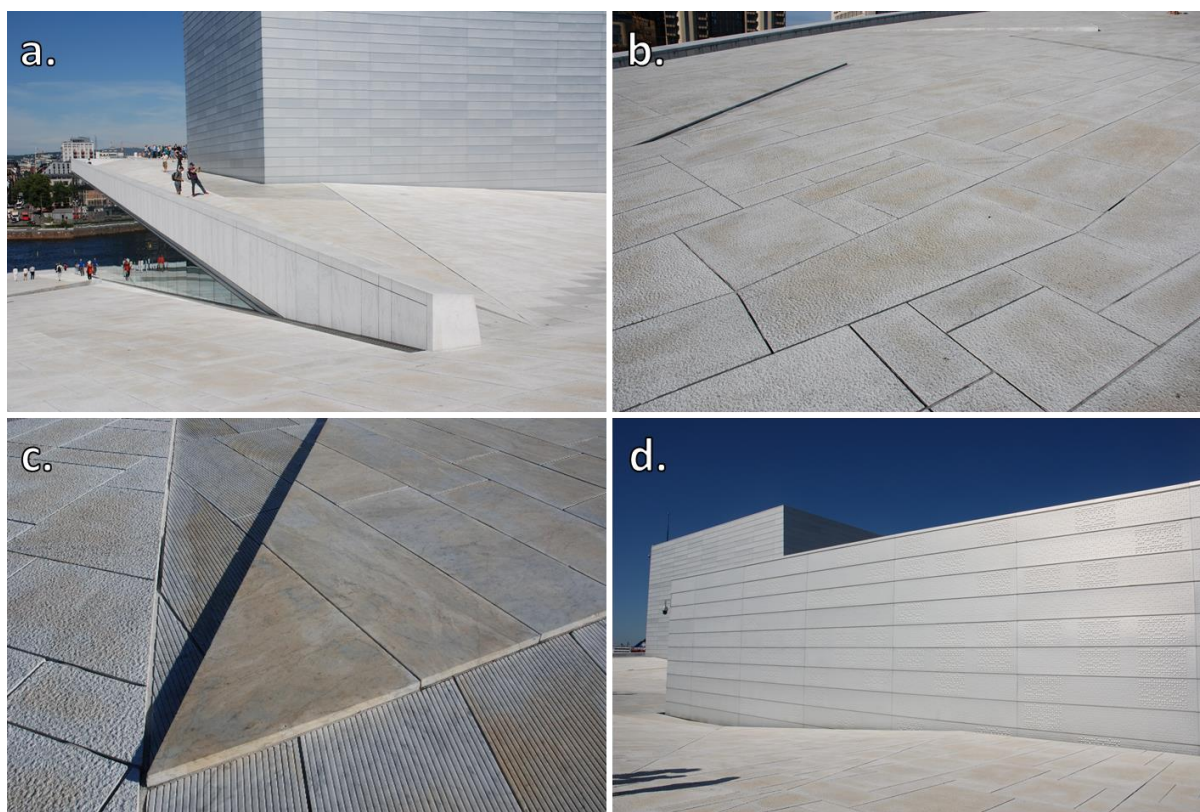
Figure 1. The Oslo Opera House: a) Vertical surface cladding and b) ornamental pavement slabs made of Carrara marble, characterized by c) different surface finishings; d) vertical surface cladding made of aluminum sheets.

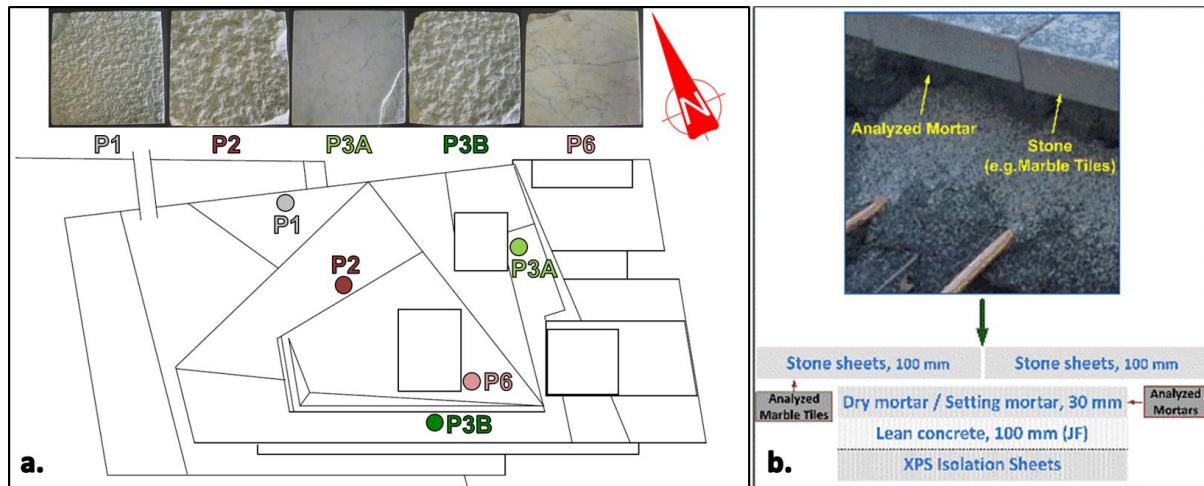
Figure 2. Location and surface characteristics of the sampled marble slabs. a.) P1, P2, P3A, P3B and P6 areas and their localization in the building plan; b.) marble slabs mounting during construction and cladding technology and materials. *Courtesy of Statsbygg* [9].

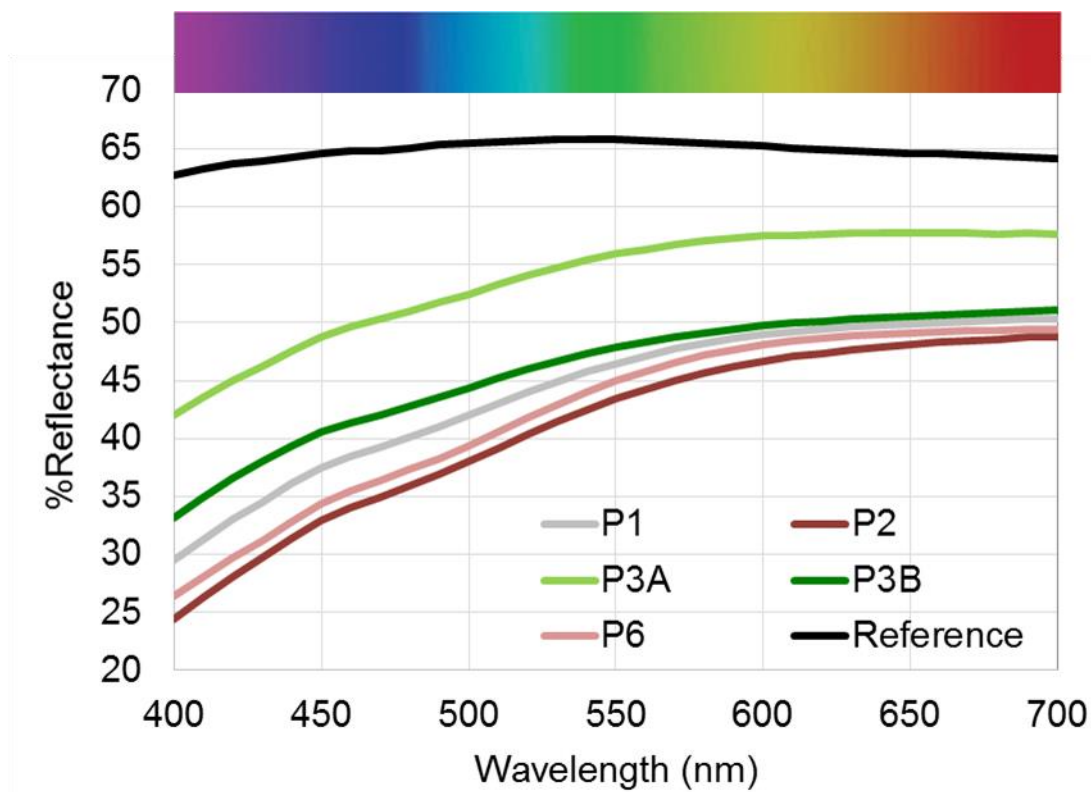
VIS reflectance measurements of both unexposed and exposed surfaces of marble samples provide a quantitative basis to the visual perception of the alteration of colour. Compared to the reference sample, P1-P6 slabs exhibit a remarkable decrease in L*, that accounts for a loss of brightness, and an increase in b* values which represents the saturation of the yellow component in the CIE L*a*b* system (Table 2). Reflectance curves (Figure 3) display a general decrease in reflectance values as compared to the white reference marble slab and a marked decrease at wavelengths lower than 500 nm with shoulder peaked at 450 and around 570 nm. Indeed, the former feature can be linked to the decrease of the observed L* values while the two shoulders account for the general yellowing. Among them, P2 and P6 slabs are those showing a more intense discolouration with an increase of b* coordinate of 12 units (Table 2 and Figure 3).

Figure 3. Reflectance spectra obtained from Vis spectrophotometric measurements on unexposed (Reference) and exposed (P1, P2, P3A, P3B and P6) slabs.

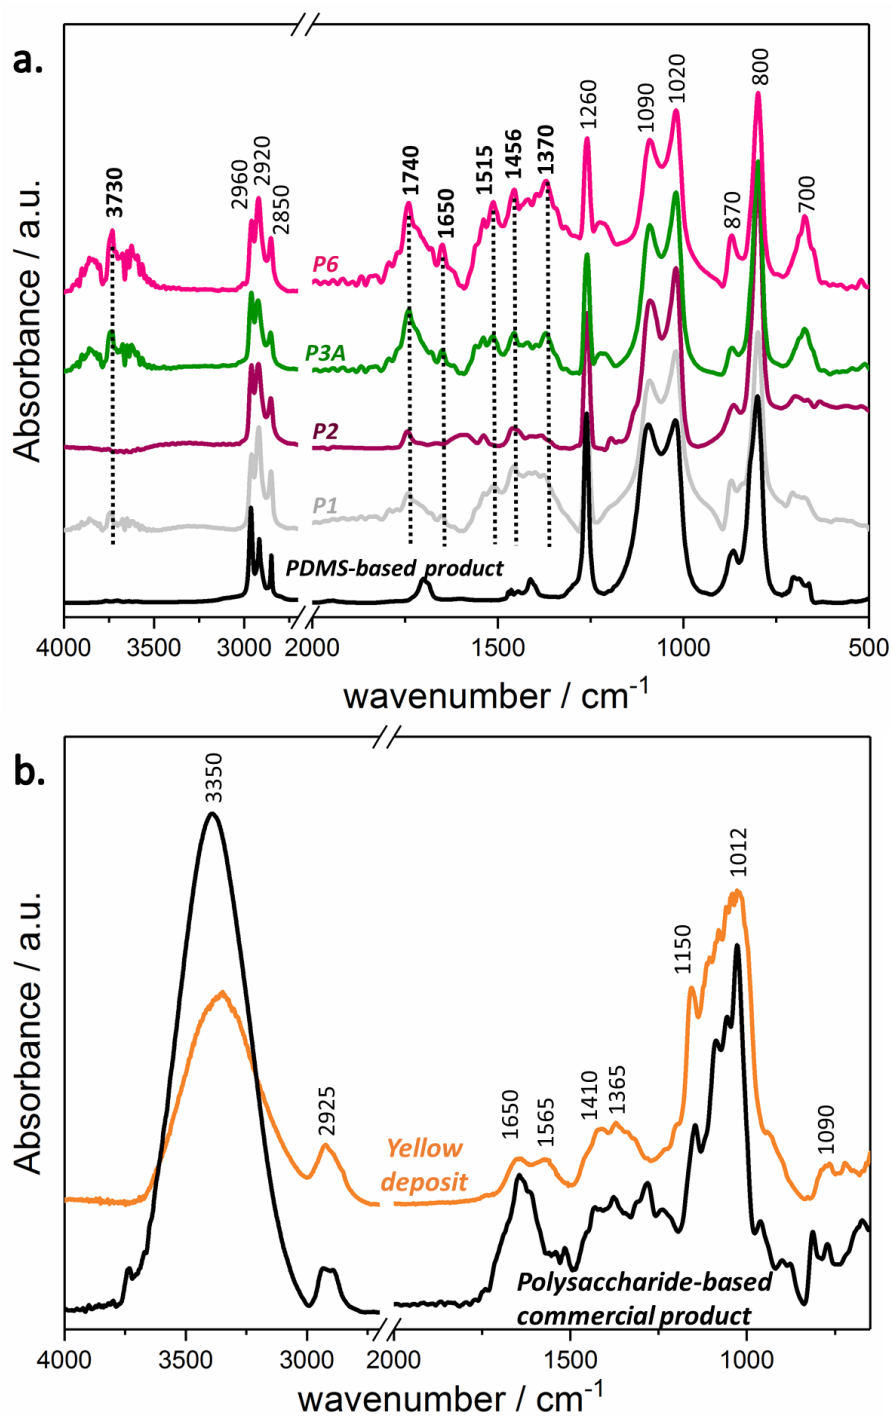
289 The FTIR spectra (Figure 8 a.) of the hexane extracts obtained from the surface of four different slabs
290 (P1, P2, P3A, P6) show a pattern of absorption peaks at 1020 and 1090 cm^{-1} (Si-O-Si stretching), 1260
291 cm^{-1} (Si-CH₃ bending), 800 cm^{-1} (Si-CH₃ rocking) and from 2950-2850 cm^{-1} (C-H stretching). These
292 signals indicate the presence of a polysiloxane macromolecule [17-20], as the comparison with the
293 reference spectrum of one of the most common siloxanes, i.e. polydimethylsiloxane (PDMS), clarifies
294 (Figure 8 a.). The finding of such product is plausible, since, to the best of our knowledge, a siloxane-
295 like product was most probably applied on marble slabs in 2012, yet the chemical composition of this
296 coating remains unknown to us, hence it must be emphasized that the reported reference spectrum
297 does not necessarily refer to the product actually applied few years ago on marble. Moreover, further

298 signals can be observed in the spectra of the materials extracted with different organic solvents, which
299 clearly point to the co-presence of other organic compounds. Indeed, the peak around 1740 cm^{-1} (C=O
300 stretching of esters) and the multiple peaks in the range from 1650-1510 cm^{-1} (not readily
301 interpretable but possibly comprising the COO⁻ stretching vibrations of carboxylate ions) suggest the
302 presence of esters and carboxylates [21], while the wide band between 3800-3300 cm^{-1} (O-H
303 stretching) is evidence of the presence of free hydroxyl groups. These signals were observed in the
304 spectra of extracts up to several millimeters under the surface, extending as deeply as the yellowing
305 of marble, whereas signals ascribable to the siloxane backbone were only detected on the marble
306 surface. Their co-extension with the yellowing suggests that they may be degradation products, with

307 a likely implication in the discolouration of marble, yet their source and formation mechanism are
308 open to speculation and FTIR analysis does not provide any conclusive evidence thereon. ~~It cannot be~~
309 ~~ruled out that the polysiloxane compound may be at the origin of these degradation products, possibly~~
310 ~~through the detachment of a fatty acidic moiety (which is present in some commercial products).~~ Since
311 the yellowing had already appeared on marble slabs when the polysiloxane coating was first applied,
312 it might be speculated that the degradation process is related to one of the treatments applied earlier
313 (2007-2008), i.e. Faceal Oleo HD (a fluorinated acrylic copolymer) and PSS20 (a polysaccharide based
314 material). The cleaning procedure carried out with hot water, high pressure and with the addition of
315 an alkaline cleaning product could have played a role in the degradation of the protective treatments.

316 The FTIR spectra (Figure 8 b.) of the localized yellow-brown deposits collected from the surface of
317 marble slabs show the typical features of a polysaccharide compound. This is evident through the
318 strong absorption bands around 3350 cm^{-1} and from 1000-1150 cm^{-1} , which are typically the most
319 intense signals in the spectra of polysaccharides, related to the O-H and C-C-O stretching vibrations,
320 respectively [22]. Furthermore, a comparison with the spectrum (Figure 8 b.) of PSS20, the commercial

321 anti-graffiti product that was applied on marble slabs in 2007-2008 and is based on a natural
322 polysaccharide, indicates with strong probability that the yellow-brown deposits are residuals of this
323 treatment. Among the other signals, a peak at 1650 cm^{-1} can be noticed. This peak is difficult to assign
324 univocally, but, according to one reasonable hypothesis, it may be related to the O-H bending vibration
325 of adsorbed water, which can be found in variable content in the spectra of these compounds [22]. It
326 is important to underline that, despite of their colour, these deposits do not represent the main origin
327 of the extended yellow discoloration of the marble.

Figure 8. a.) FTIR spectra of the extract with hexane from surface powder of P1, P2, P3A and P6 slabs and the spectrum of a reference poly(dimethylsiloxane)-based product (PDMS); b.) FTIR spectrum of a yellow deposit collected from P1 slab and the spectrum of the polysaccharide-based commercial product (PSS 20).

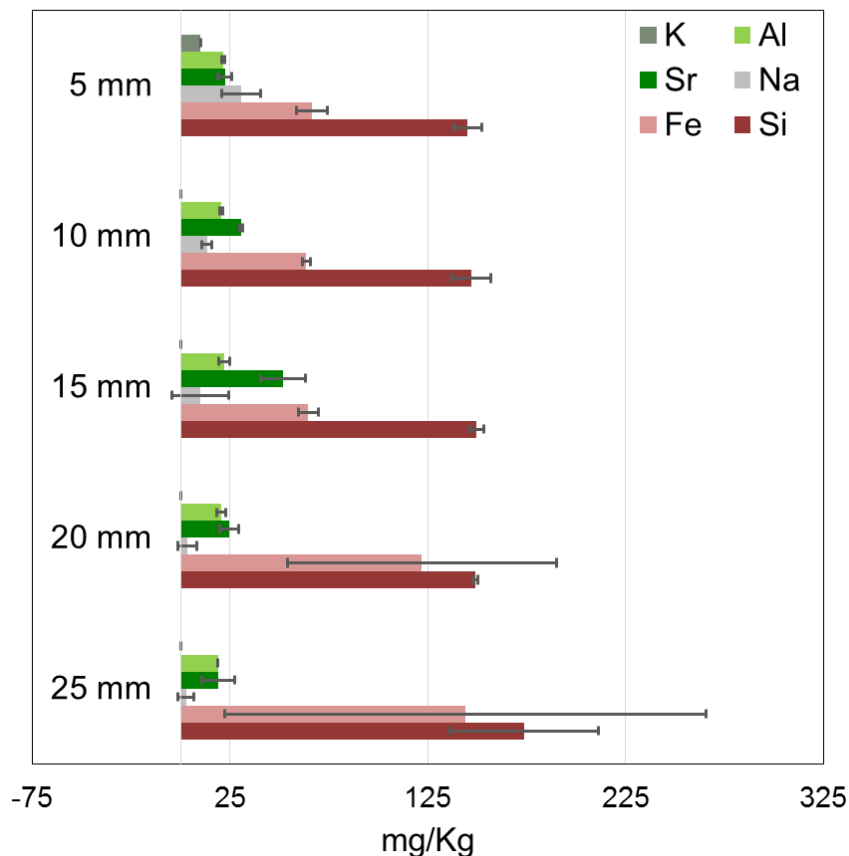
By observing the cross-section of the marble slab perpendicular to the external surface, it has been evidenced that the yellowing phenomenon affects a thickness of about 20 mm inside the stone material (Figure S1). Two sets of samples collected from the P6 marble slab were analyzed by ICP-OES, aiming at assessing the quantitative elemental composition at different depths from the surface. As far as the carbonatic matrix of the stone is concerned, the content of Ca and Mg is 39.6 (%w/w) and 0.46 (%w/w) respectively, for the examined samples at different depth, and this represents the calcite and dolomite content of the marble. The average elemental (Si, Fe, Na, Sr, Al and K) composition (mg/Kg, ppm) of the two sets of samples is reported in Figure 9, whereas the contribution of Ti, Zn and Zr is not evidenced since their amount is below the detection limit (< 5 mg/Kg). The concentration of Al, Si and Sr is rather constant at the different considered depths for both sets of samples (Figure 9). The high Si content is related to the presence of quartz crystals in the marble. The Fe concentration in one set of samples is rather constant at the different depths, whereas it significantly increases at higher depths (20 and 25 mm) in the second one. This issue explains the high values of standard deviations of Fe concentration in samples collected at 20 and 25 mm from the surface (Figure 9). These results clearly suggest that the surface yellowing should not be correlated to the accumulation of iron-based compounds (iron oxides or hydroxides) on the surface, up to the first 20 mm. The increase of iron content at a specific depth (25 mm) inside the second set of samples can be correlated to the presence of some pyrite crystals of veins in the collected powder that have been mineralized during the analysis. Finally, the concentration of Na and K is higher on the surface of both sets of samples, as a result of the accumulation of atmospheric salt deposits (marine spray) on the surface of the slab.

Figure 9. Average elemental composition (mg/Kg, ppm) obtained by ICP-OES of 2 sets of samples collected from P6 slab at different depth from the external surface: 5, 10, 15, 20, 25 mm.

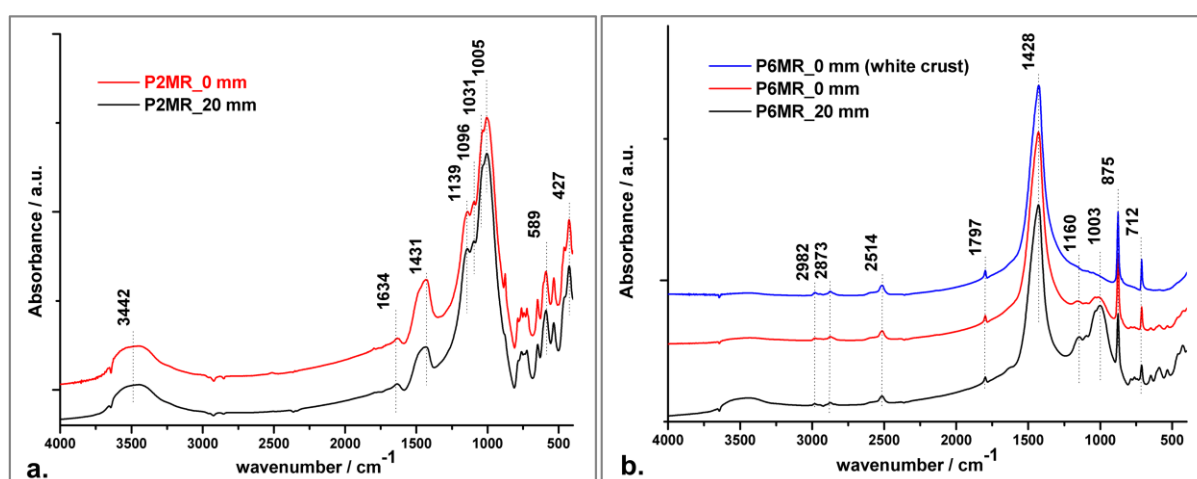
The mortars P2MR and P6MR at two different depths from the surface, along with the whitish crust of P6MR, were analysed by FTIR spectroscopy. P2MR mortar sample (Figure 10 a.) consists of calcite

(1431 cm^{-1}), hydrated alumino-silicate and siloxane components which exhibited absorption peaks in the spectral range 1000 – 1100 cm^{-1} (1005, 1031 and 1096 cm^{-1}). It is well established that the SiO_4^{4-} vibration of the CSH compounds of cement show infrared absorption bands in the range of 970-990 cm^{-1} [26]. The sharp peaks in the range 1000-1100 cm^{-1} shown in the Fig. 10 a. are attributed to the Si-O-Si due to siloxane admixtures in the mortars. The presence of hydrated sulphates is indicated by absorptions at 3442, 1634, 1139 and 589 cm^{-1} . The infrared spectrum of the whitish upper layer of P6MR mortar reported in Figure 10 b., showed absorption peaks of calcite with traces of absorptions in the range 1000-1100 cm^{-1} attributed to Si-O-Si bonds of CSH and siloxane components; the latter increase in the spectra of the internal part of the mortar sample (20 mm). The high content of calcite should be ascribed to the residual marble adhered to the cement bedding mortar and could be considered as an indication of no migration of the components of bedding mortar through the marble.

Figure 10. FTIR spectra of both sides of P2MR (a.) and P6MR (b.) mortars.

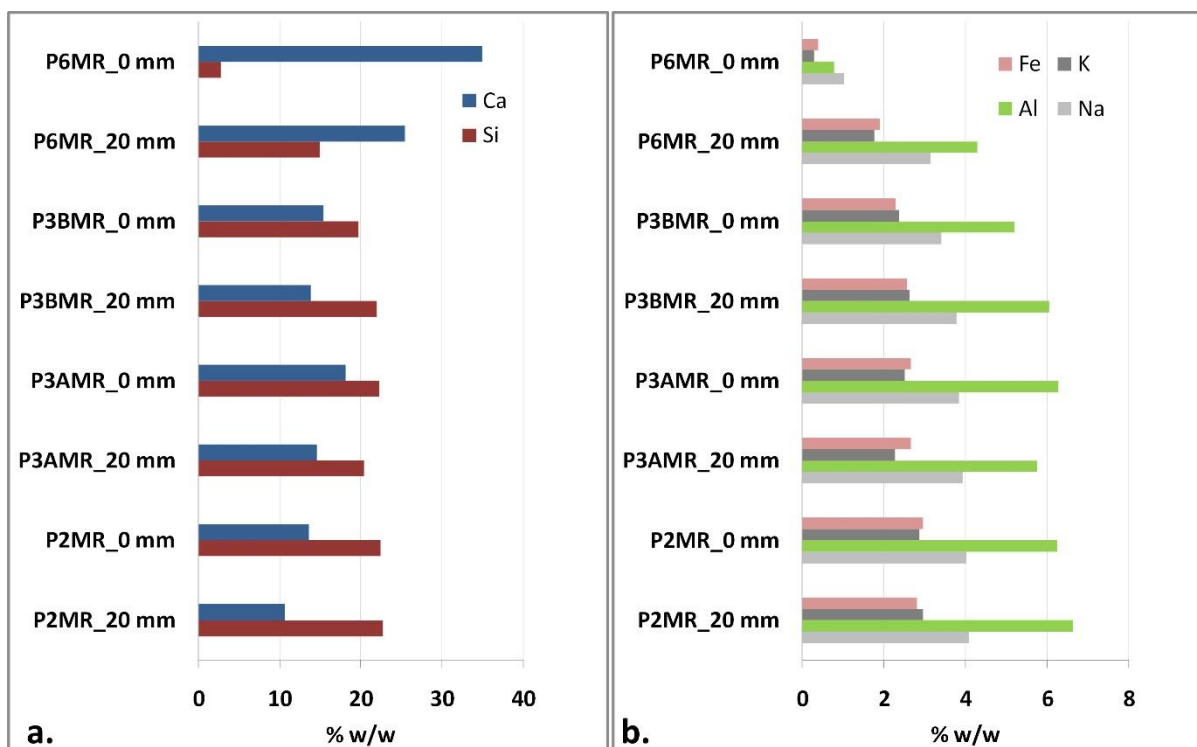
The diagram of Figure 11 a. compares the concentration of Si and Ca (%w/w) identified in all the mortars. The lowest content of Si that was detected for P6MR_S sample can be correlated with the high Ca concentration due to the marble residue adhered to the mortar and it is in agreement with the results of FTIR. Moreover, the considerable Na amount detected in the mortars is in good agreement with the Na quantity found in the lower side of the marble slab, which were in direct contact with the mortars. Finally, it is important to highlight that no Fe migration occurred from the mortars to the marble slabs. This becomes evident from the lowest Fe amount detected in the P6MR_0 mm sample (Figure 11 b.), which reflects the residual marble adhered to the mortar.

Figure 11. EDXRF analysis on the surface and up to a depth of 20 mm of the studied mortars.
